**HARDLOCK®**

Self-Locking Nut

HARDLOCK Nut (HLN)

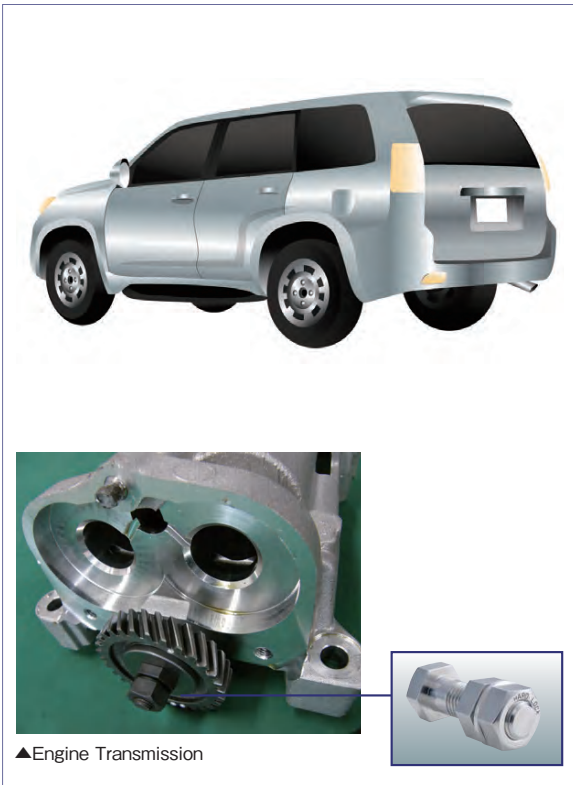
HLN SUV Engine Transmission

- Flanged Nuts were utilized in the engine transmissions of SUVs
- Loosening of nuts occurred frequently when starting the engine and many SUVs had to be recalled.

- By switching from Flanged Nuts to HARDLOCK Nuts the loosening problem was resolved.
- By utilizing HARDLOCK Nut the loosening occurring when starting the engine were also resolved.

- Loosening due to cyclic stress in the rotational direction of the bolts axis

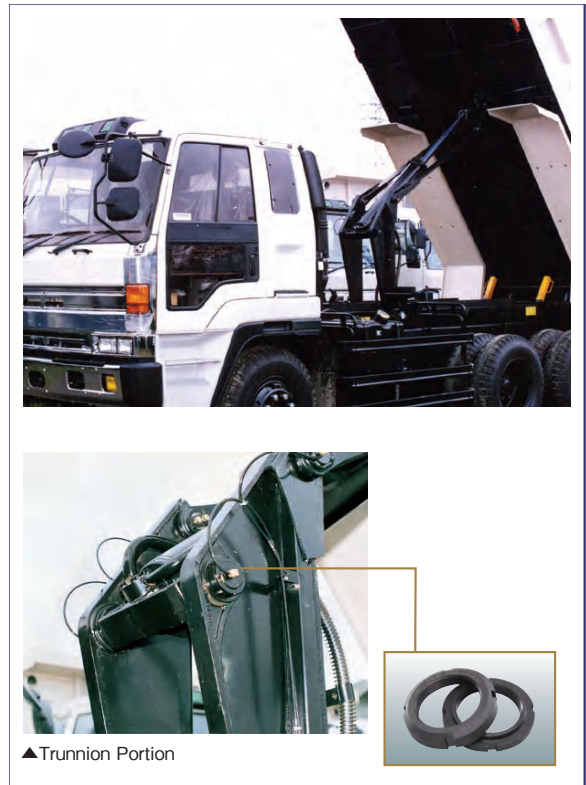
HLB Specially equipped vehicle trunnion fixing

- Double bearing nuts were used as a countermeasure for loosening
- The double bearing nuts were tightened by the "double nut method". However, loosening occurred due to the variation in tightening force.

- By adopting the HARDLOCK Bearing Nut, the workability was improved and the loosening problem was solved.
- By switching to HARDLOCK Nut, the maintenance costs were significantly reduced

- Loosening due to cyclic stress in the rotational direction of the bolt axis

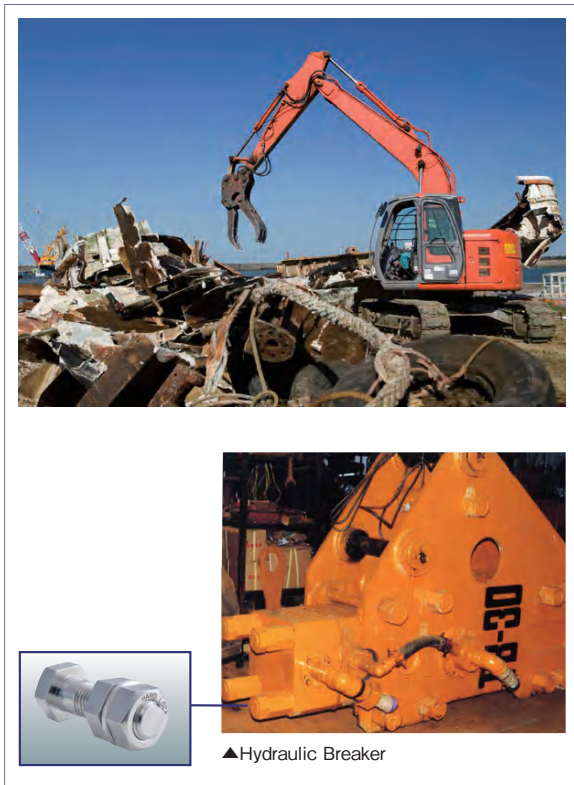
HLN Hydraulic Breaker

- Loosening caused by severe impact vibration from crushing operations at mines and large quarries occurred on a regular basis. Double nuts were used and carried out a high-torque fastening and dropout prevention measures, but the problem was not solved.

- By introducing HARDLOCK Nut, axial force management by proper torque and loosening prevention was achieved

- Loosening due to cyclic stress in the direction perpendicular of the bolts axis

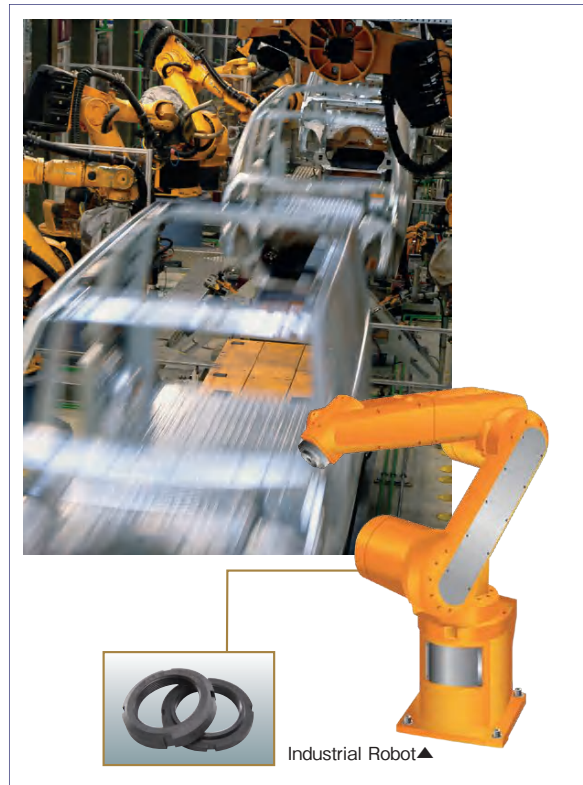
HLB Industrial Robot Arm Joint

- Prevailing torque type self-locking nuts where used were in the arm portion, but iron powder produced by the friction between the nut and shaft caused poor movability.
- Torque control was difficult with prevailing torque type self-locking nuts and there was a problem with variety in axial force.

- By switching to HARDLOCK Bearing Nut the problem with shaft damage was resolved.
- Axial force management by proper torque combined with elimination of loosening improved the product performance of the industrial robots.

- Loosening due to cyclic stress in the rotational direction of the bolt axis

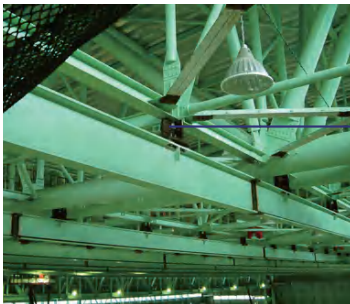
▲Rail Fastening Portion

- Prevailing torque nuts were used for indoor overhead cranes. However, due to excessive vibration loads they became loose on a regular basis.
- Due to the everyday loosening, re-tightening works etc., maintenance cost was increased immensely.

- By changing to HARDLOCK Nuts, loosening in the fastening portions of the cranes was eliminated.
- As a result, stable operations and reduction in maintenance work lead to significant cost savings.

- Loosening due to cyclic stress in the direction perpendicular of the bolt axis

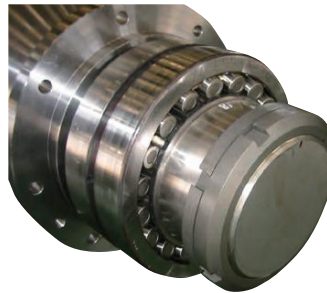
▲Mill Roll

- To prevent loosening at steelwork equipment lines, the shafts has key grooves and is fastened with both toothed washers and nuts as well as welding in some instances.
- In recent years, steelwork facilities are continuing with a fire-free work environment. Therefore, welding and such other procedures have been minimalized.

- Loosening due to cyclic stress in the rotational direction of the bolt axis
- Loosening due to cyclic stress in the direction perpendicular of the bolt axis

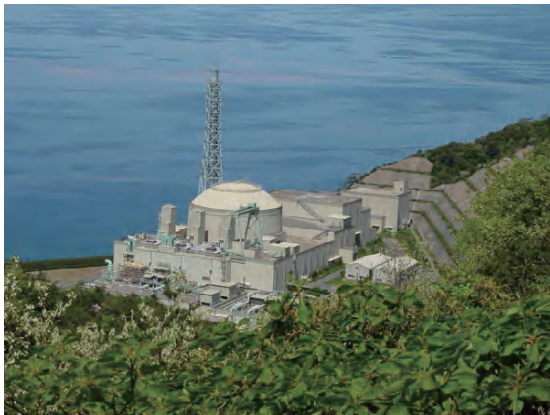
▼Piping Support

- Double nuts were used in the fixed stand of the reactor core and piping supports in the power plant. Retightening work and maintenance were required on a daily basis due to frequent loosening.
- Since nuclear power plants are large in size and places where nuts are used are plenty, huge amounts of maintenance cost and maintenance time was necessary.

- HARDLOCK Nut demonstrated superior self-locking performance and prevention of loosening.
- Safety in the nuclear power plant facilities increased, time spent on maintenance and maintenance cost was reduced immensely.

- Loosening due to micro-motion abrasion
- Loosening due to thermal causes

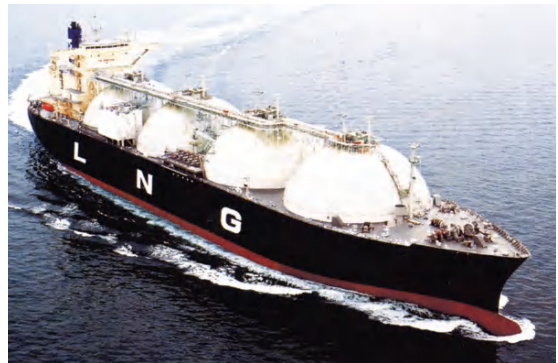
▼Ship Engine

- Double nuts were used on the internal combustion engines of the ship, loosening due to thermal expansion and severe vibration occurred on a daily basis.
- Retightening work had to be made frequently and an enormous amount of time and cost was spent on maintenance.

- By switching to HARDLOCK Nut with special coating, Loosening due to vibration and/or thermal expansion was eliminated.
- Significant reduction in maintenance cost as well as retightening work.

- Loosening due to micro-motion abrasion
- Loosening due to cyclic stress in the direction perpendicular to the bolt axis
- Loosening due to thermal expansion

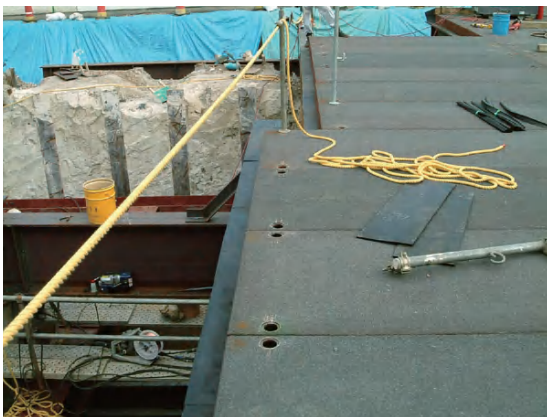
▲ Road Plates

- Countermeasures such as welding and insertion of cushioning materials to reduce vibration in the road plates were carried out. However, due to poor welding and replacement of cushioning material work, both options were unsatisfactory.
- Another serious problem was the noise control due to collision of the road plates when vehicles passed over them.

- By switching to HARDLOCK Nut in the connection portion of the road plates, problems such as loosening were eliminated.
- Additionally, the noise generated when vehicles pass over the road plates was eliminated and overall costs were reduced.

- Loosening due to cyclic stress in the direction perpendicular to the bolt axis

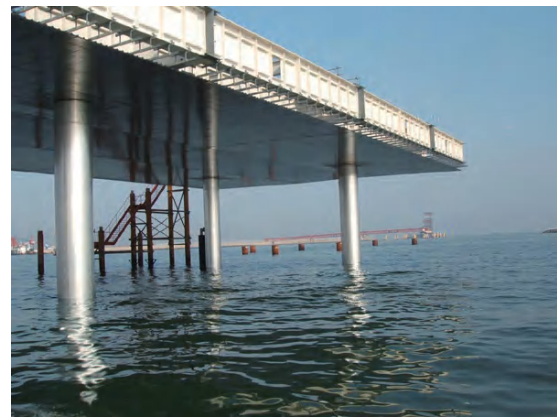
◀ Pier Cover Plate Mounting

- During the construction of the titanium panel on artificial grounds rear surface of the offshore airport, prevailing torque self-locking nuts were studied.
- Since the prevailing torque type self-locking nuts caused scratches on the bolt (peeling off the plating), rust occurrence was a serious problem and concerns regarding safety and corrosion resistance arose.

- By switching from prevailing torque type self-locking nuts to HARDLOCK Nuts, problems related to bolt damage and corrosion were eliminated.
- Loosening due to severe vibration in the pier cover plates during landing and take-off of aircrafts were eliminated, HARDLOCK Nut also corresponded to the 100 year warranty requested by the Ministry of Land, Infrastructure and Transport.

- Loosening due to micro-motion abrasion
- Loosening due to cyclic stress in the direction of the bolt axis

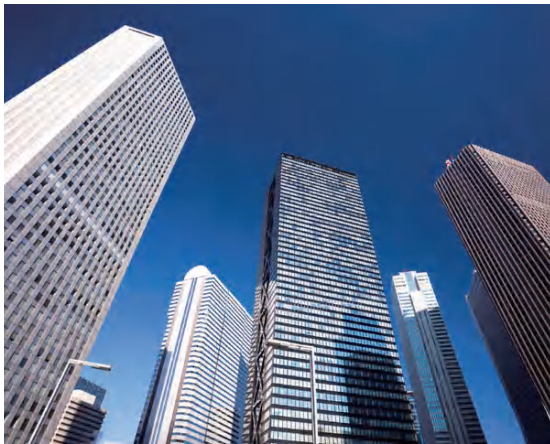
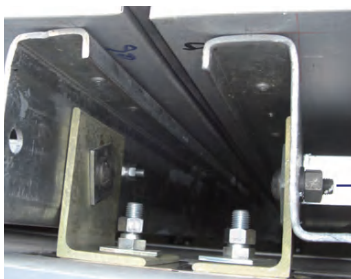
◀ Exterior Wall Mounting

- Aluminum curtain walls were mounted on the exterior walls of high-rise buildings with metallic fastener, but due to the high torque required to tighten the metallic fasteners, it caused expansion of the aluminum which would cause a specific sound.

- Loosening due to cyclic stress in the direction perpendicular to the bolts axis
- Loosening due to thermal causes

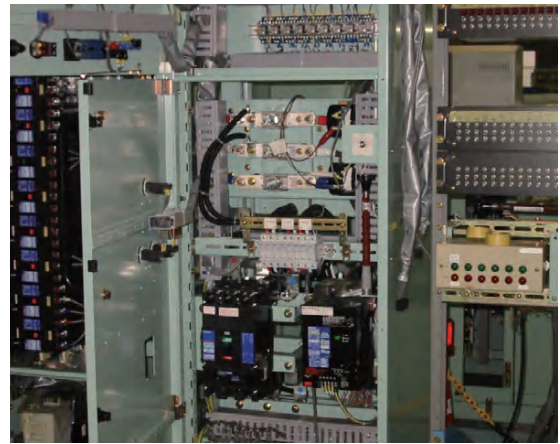
◀ Distribution Boards

- Double nuts or spring washer were used, loosening due to vibration caused during product transportation was a regular occurrence.
- Loosening after installation due to micro-vibration during operation occurred on a daily basis.

- By switching to HARDLOCK Nut, due to proper torque control, loosening during transportation and/or operation was eliminated.
- Significant savings in labor was achieved due to eliminating re-tightening work.

- Loosening due to micro-motion abrasion

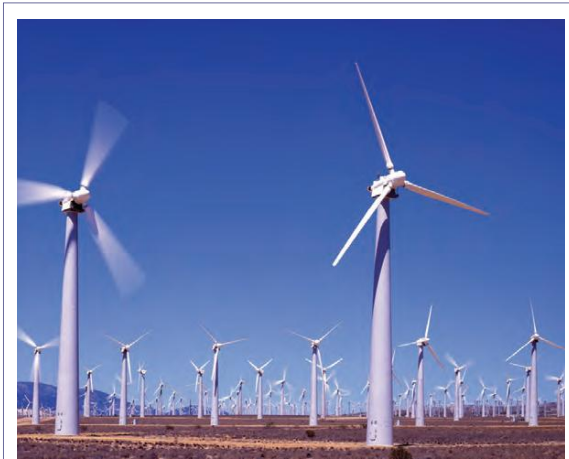
Cable Rack in Turbine Towers ▶

- Wind turbine towers are installed in areas where there are strong winds, due to the irregular stress induced by strong winds, common double nuts and/or spring washers were not able to produce significant locking effect and eliminate loosening.
- Nylon nuts were used in the fastening portions of wiring cable racks, ladders etc. inside of wind turbine towers, however, due to the vibration caused by the rotation of the blades (wings) the Nylon nuts became loose on a regular basis.

- By switching to HARDLOCK Nut, due to successful axial force control and proper torque, loosening was eliminated.
- Regular maintenance work and equipment maintenance cost was significantly reduced.

- Loosening due to cyclic stress in the direction perpendicular to the bolt axis
- Loosening due to micro-motion abrasion

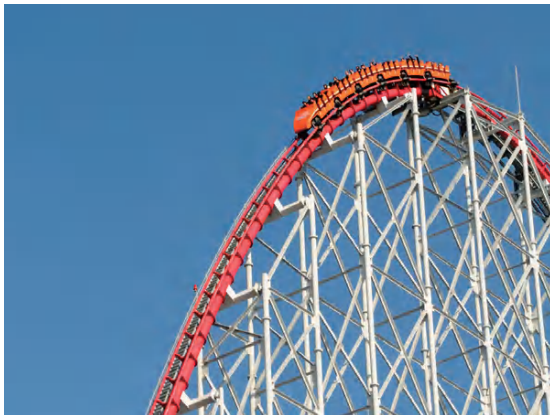
▲Guide Roller Portion

- Loosening due to cyclic stress in the rotational direction of the bolt axis
- Loosening due to cyclic stress in the direction of the bolt axis

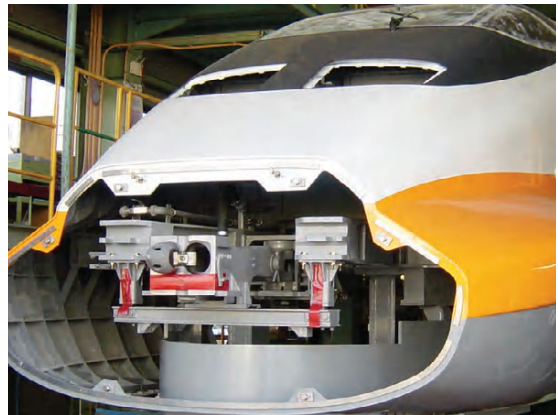
▼Shinkansen Tight Coupler

- In high speed rail cars, repeated impact of the rail coupling causes the nut to loosen and may even risk detachment. Damage to friction ring also causes the nut to loosen.

- By using the HARDLOCK Nut, even under repeated impact, loosening is prevented and detachment does not occur. Breakage of the friction ring is eliminated by using the HARDLOCK Nut and has been adopted by many rail car manufacturers.

- Loosening due to cyclic stress in the direction of the bolt axis
- Loosening due to cyclic stress in the direction perpendicular of the bolt axis

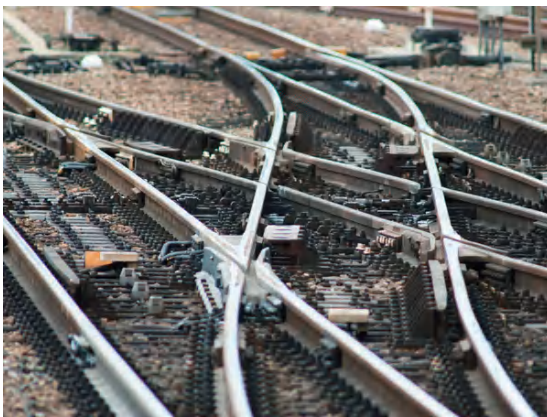
▲Railroad Switch

- When a train passes, a force of 500G is applied to the switch, and even specially shaped double nuts used on the movable parts can become loose on a daily basis.
- While the switch (movable part) is essential to maintain the track gauge, it is extremely difficult to maintain the gauge of the track while preventing loosening.

- By using the HARDLOCK Nut, the maintenance cost associated with inspection and re-tightening was successfully reduced.
- The HARDLOCK Nut successfully maintained the gauge of the track and prevents loosening simultaneously. As a result, the HARDLOCK Nut has been adopted by all railway companies in Japan.

- Loosening due to cyclic stress in the direction of the bolt axis
- Loosening due to cyclic stress in the direction perpendicular of the bolt axis

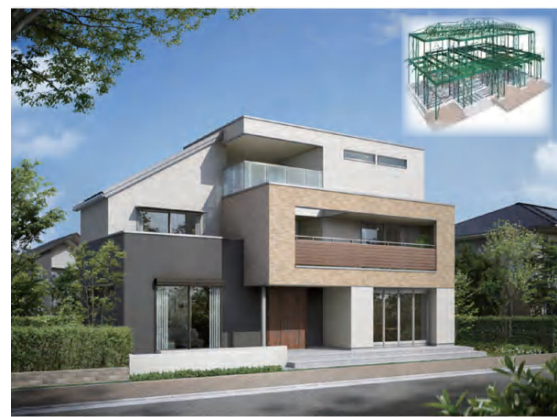
▲Steel Frame joint

- Conventionally, based on the Building Standards Law, Single Nuts and Spring Washers was going to be used in the Light-gauge Steel Joint as a countermeasure for loosening.

- Loosening due to cyclic stress in the direction of the bolt axis
- Loosening due to cyclic stress in the direction perpendicular of the bolt axis

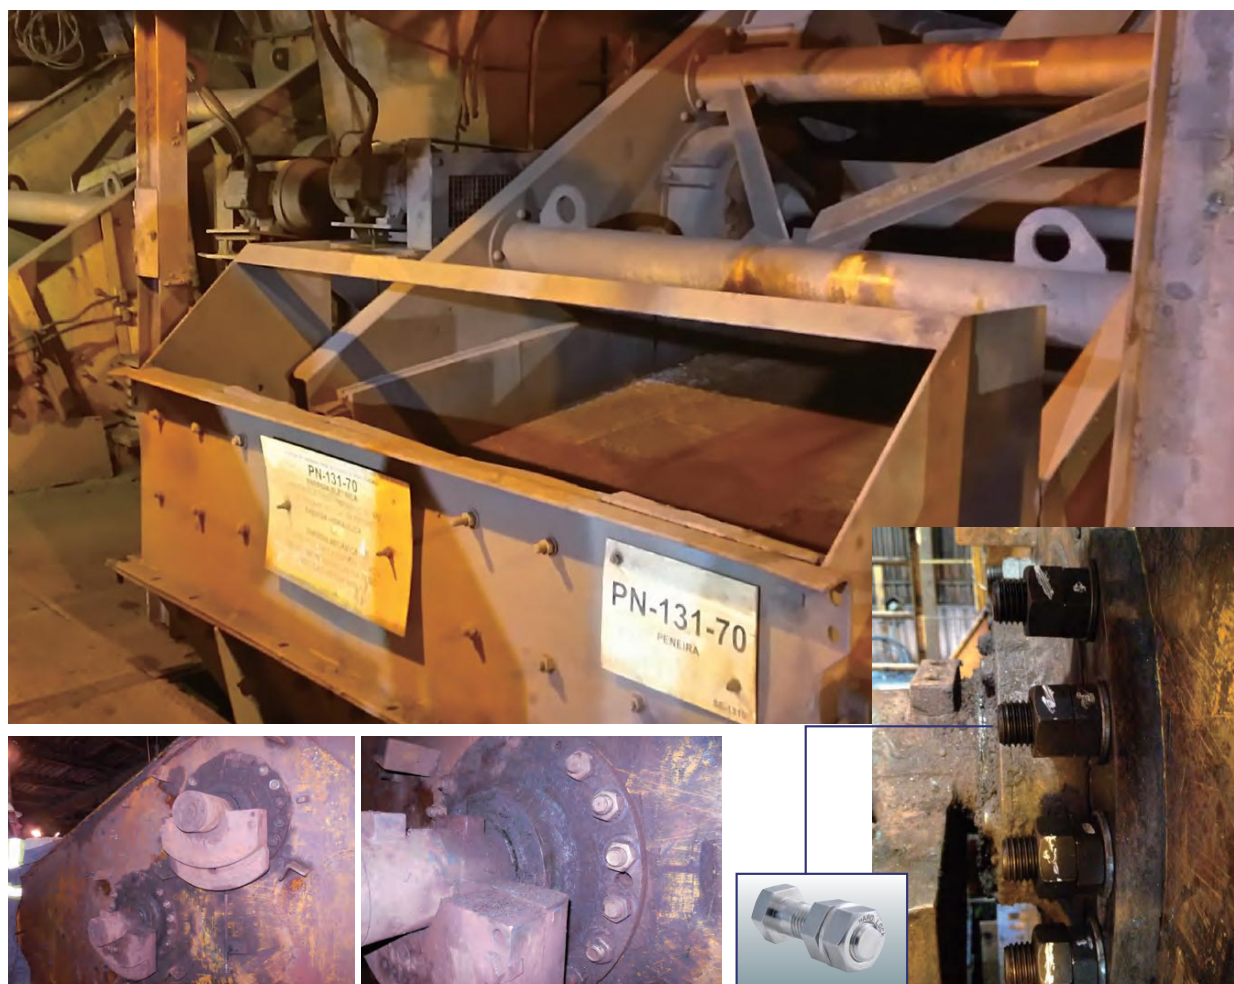
Pendulum Fastening for Vibration Screens

- Loosening due to cyclic stress in the direction perpendicular of the bolts axis
